# **INDOOR AIR QUALITY ASSESSMENT**

**Massachusetts Department of Mental Retardation  
Hogan Regional Center, 2 Hathorne Circle  
Village of Hathorne, Danvers, Massachusetts**

Prepared by:  
Massachusetts Department of Public Health  
Center for Environmental Health  
Bureau of Environmental Health Assessment  
Emergency Response/Indoor Air Quality Program  
December 2004

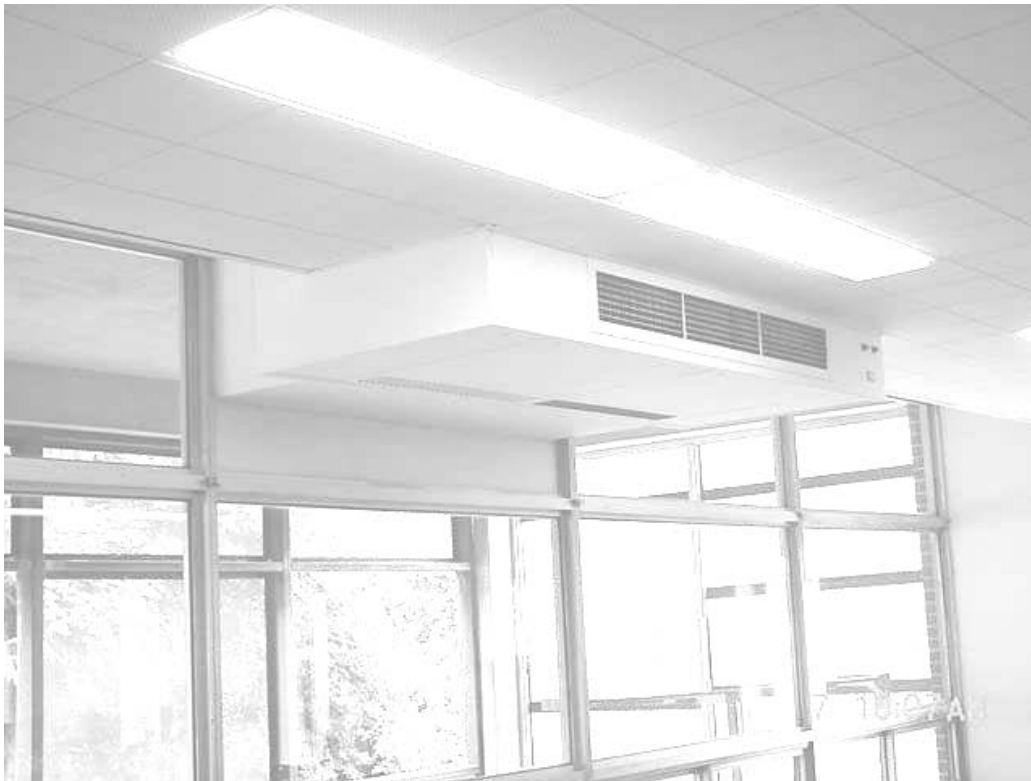
**Picture 1**

Fresh air is supplied by a unit ventilator (univent) system (Picture 1). Univents draw air from outdoors through a fresh air intake located on the exterior walls of the building (Pictures 2 and 3) and return air through an air intake located at the base of each unit ([Figure 1](#)). Fresh and return air are mixed, filtered, heated and provided through an air diffuser located in the top of the unit. The majority of univents were not operating during the assessment. Therefore, no mechanical means of introducing fresh air were being provided. In order for univents to provide fresh air as designed, they must remain operating while rooms are occupied.

**Ceiling-Mounted Univent**

1. Implement recommendations listed in the previous BEHA letter regarding mold remediation in the basement storage room (MDPH, 2004).
2. Survey univents to ascertain function and determine whether an adequate air supply exists for each room. Consider consulting a heating, ventilation and air conditioning (HVAC) engineer concerning the calibration of univent fresh air control dampers throughout the building.

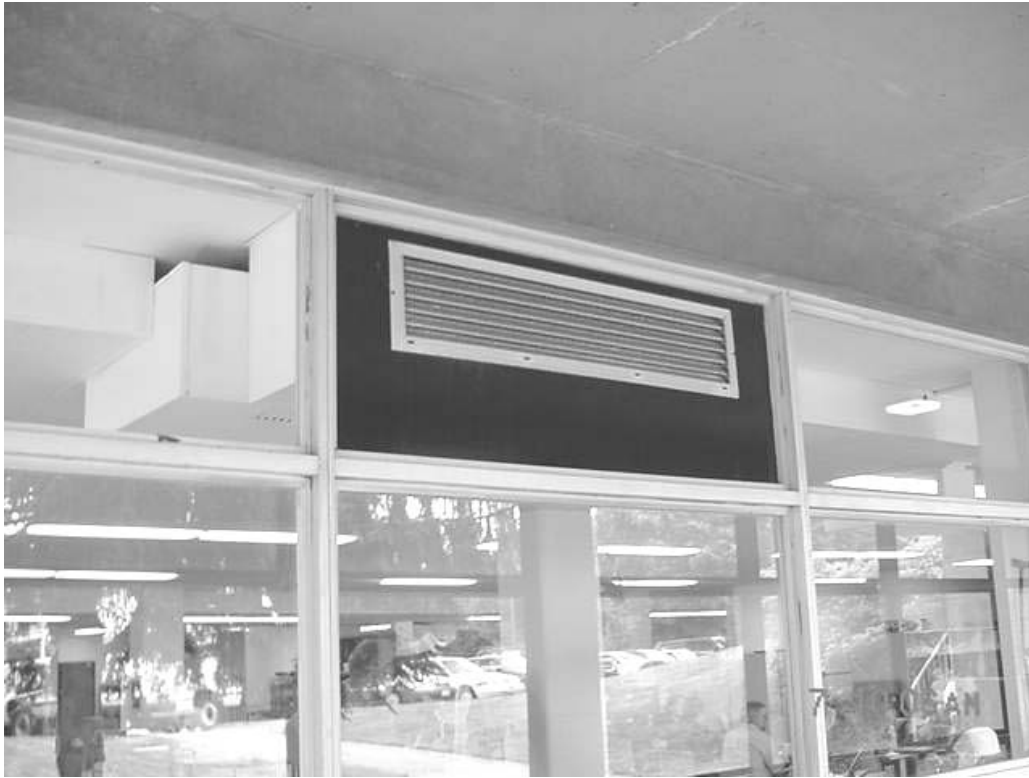
**Picture 2**

**Air Intake for Ceiling-Mounted Univent**

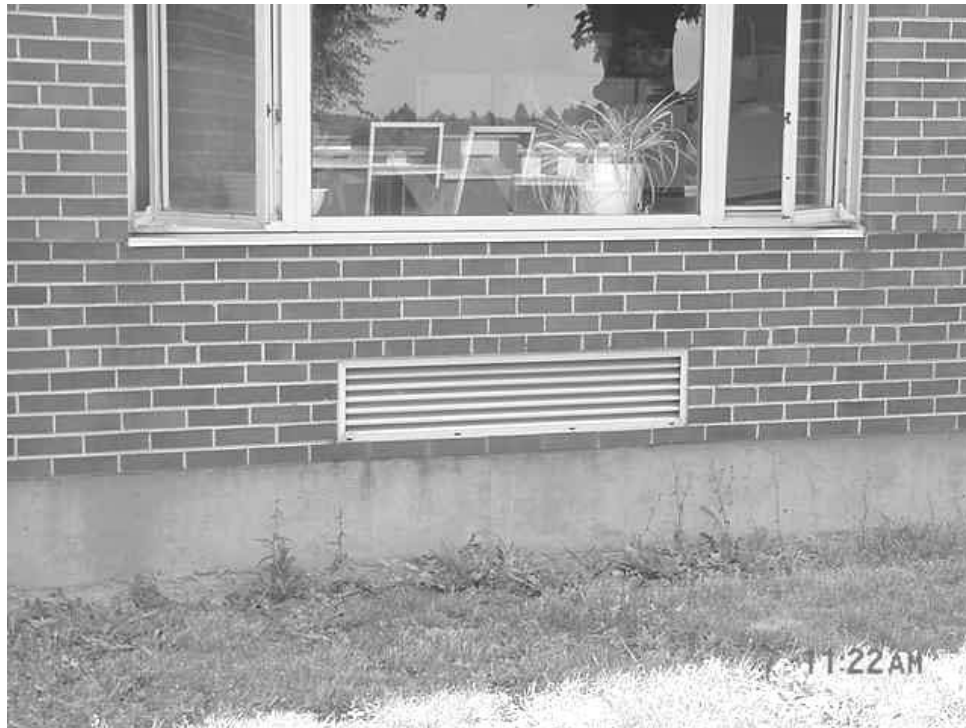
**Picture 3**

**Air Intake for Wall-Mounted Univent**

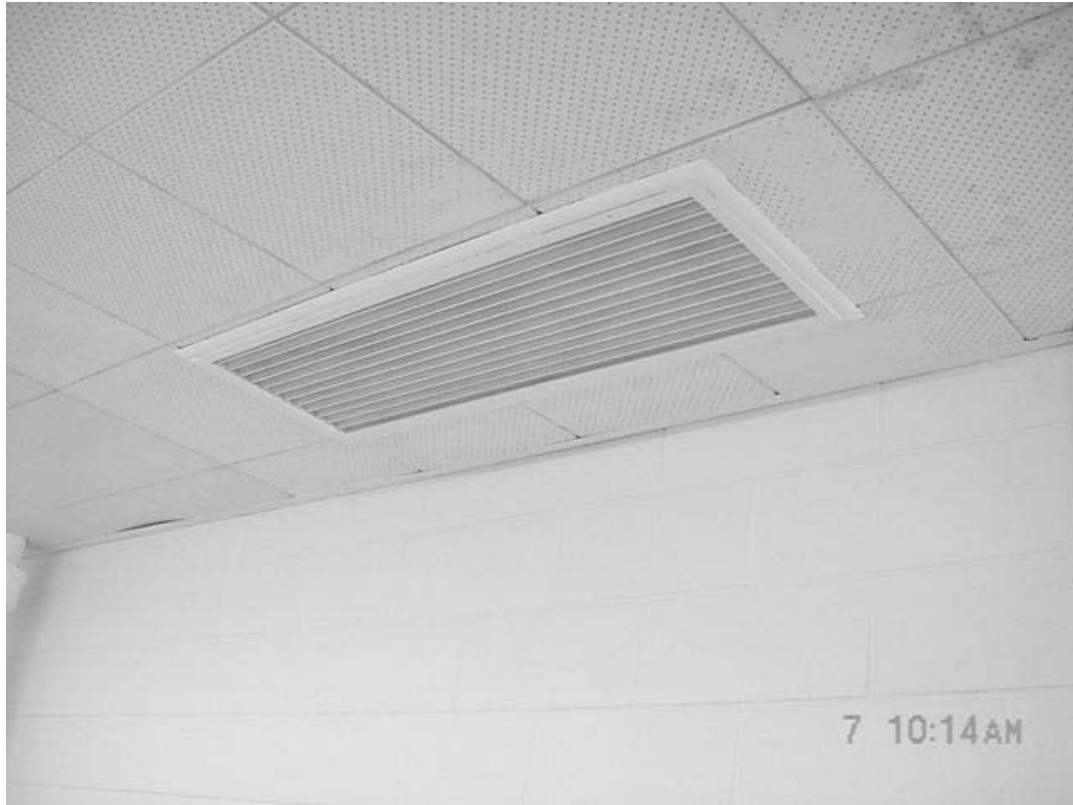
**Picture 4**

Exhaust ventilation consists of wall or ceiling-mounted vents (Pictures 4 and 5) powered by rooftop motors. The exhaust system was not drawing in a number of areas surveyed, indicating that motors had been deactivated or were non-functional. To maximize air exchange, the BEHA recommends that both supply and exhaust ventilation operate continuously during periods of occupancy. Without a means for air exchange via the mechanical supply and exhaust system, normally occurring indoor environmental pollutants (e.g. ozone from photocopiers, odors from cleaning products) can build up and lead to indoor air quality/comfort complaints.

**Ceiling-Mounted Exhaust Vent**

4. Inspect rooftop exhaust motors and belts for proper function, repair and replace as necessary.
5. Operate air conditioners in rooms without openable windows in the “Fan Only” setting to introduce outside air.

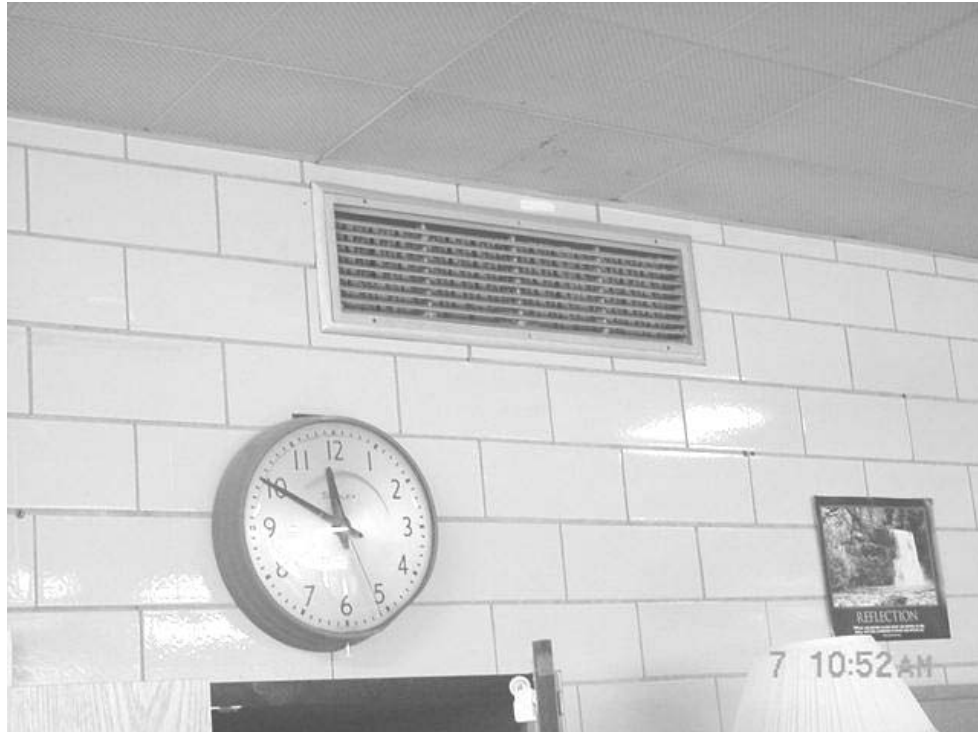
**Picture 5**

**Wall-Mounted Exhaust Vent**

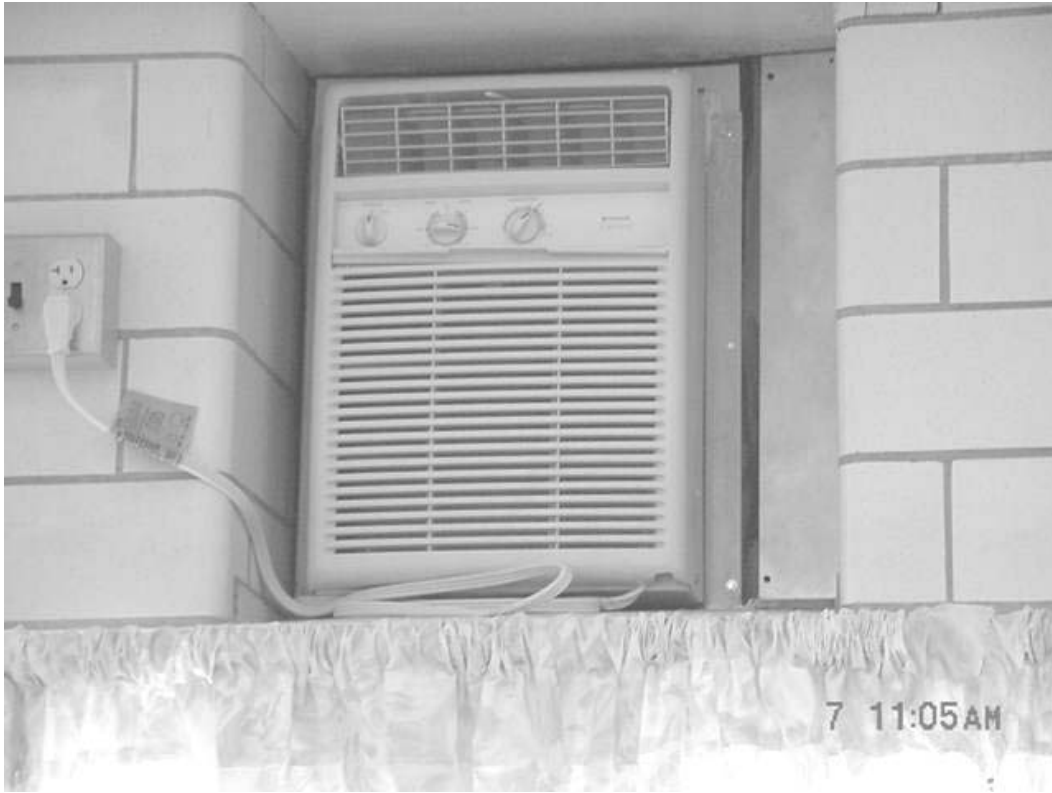
**Picture 6**

Single dorm rooms are not equipped with mechanical ventilation. Instead, fresh air is provided by open windows. In a number of cases, openable windows have been eliminated with the permanent installation of window-mounted air conditioners. However, the air conditioners are equipped with a “fan only” or “exhaust open” setting (Picture 6). When operating in either mode, air conditioning units can provide air circulation by delivering outside air without cooling (i.e., air provided by unit equals that of outside temperature).

**Window-Mounted Air-Conditioner**

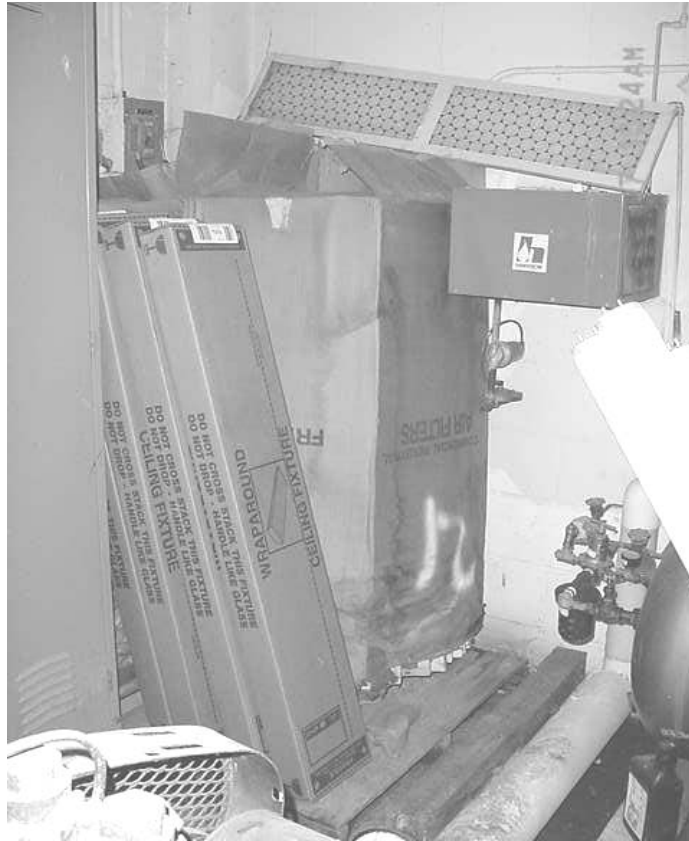
**Picture 7**

appeared water damaged (Pictures 7 and 8). The US Environmental Protection Agency (USEPA) and the American Conference of Governmental Industrial Hygienists (ACGIH) recommend that porous materials be dried with fans and heating within 24 to 48 hours of becoming wet (US EPA, 2001; ACGIH, 1989). If porous materials are not dried within this time frame, mold growth may occur. Water-damaged porous materials cannot be adequately cleaned to remove mold growth. The application of a mildewcide to moldy porous materials is not recommended.

**Water Damaged Cardboard Boxes in Mechanical Room**

8. Discard water damaged cardboard boxes and filters in mechanical room. Disinfect any areas of microbial growth with a one in ten bleach in water solution; wipe clean surfaces with soap and water after disinfection.

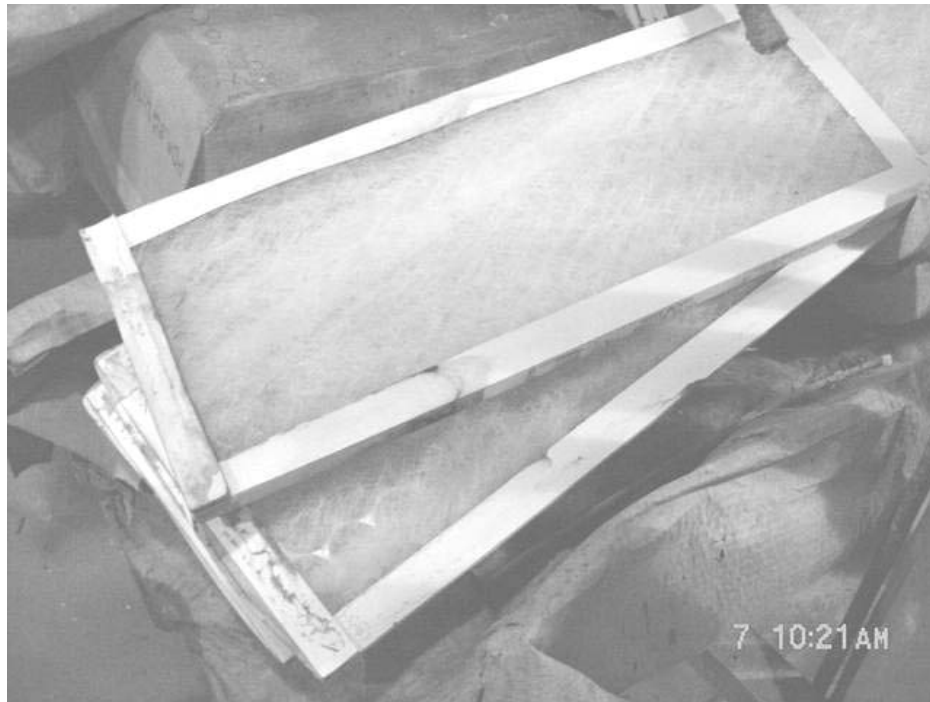
**Picture 8**

**Water Damaged Cardboard Univent Filters in Mechanical Room**

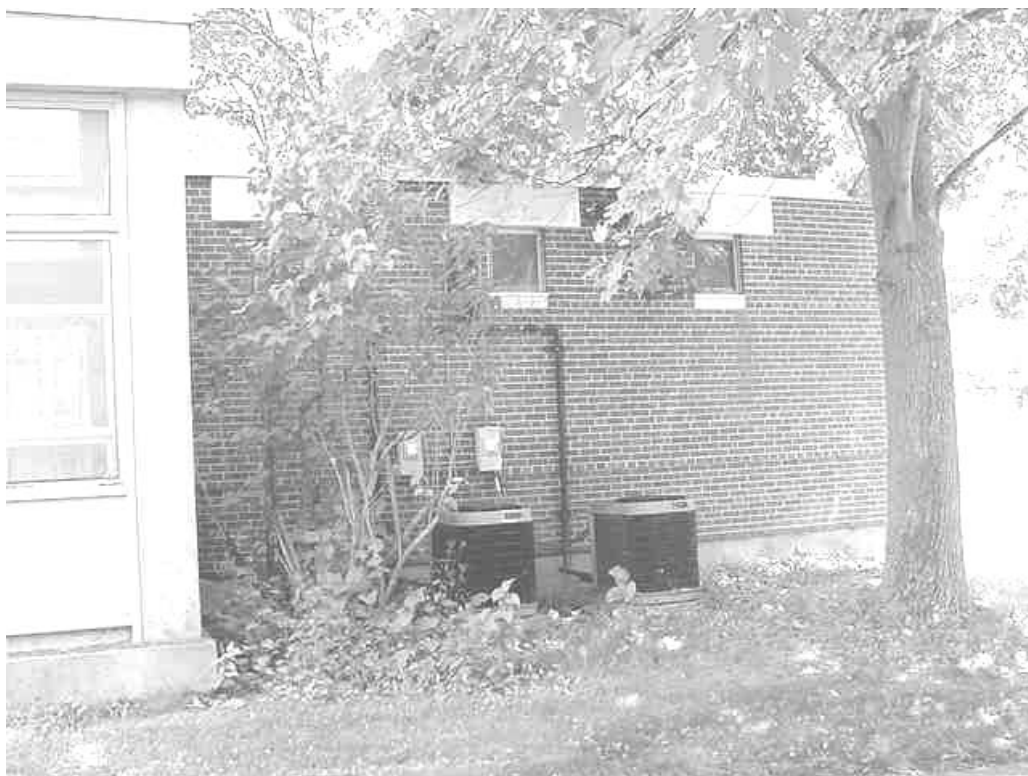
**Picture 9**

Trees and shrubbery were also noted outside the building in close proximity to exterior brickwork (Picture 9). The growth of roots against the exterior walls can bring moisture in contact with wall brick and eventually lead to cracks and/or fissures in the foundation below ground level. Over time, this process can undermine the integrity of the building envelope and provide a means of water entry into the building through capillary action through foundation concrete and masonry (Lstiburek & Brennan, 2001).

**Trees/Shrubbery in Close Proximity to Exterior Brick**

9. Remove foliage to a minimum of five feet away from the exterior of the building. Trim trees that overhang the roof.
10. Operate local exhaust ventilation in laundry room. Consider installing a variable speed dial to control fan speed/noise.

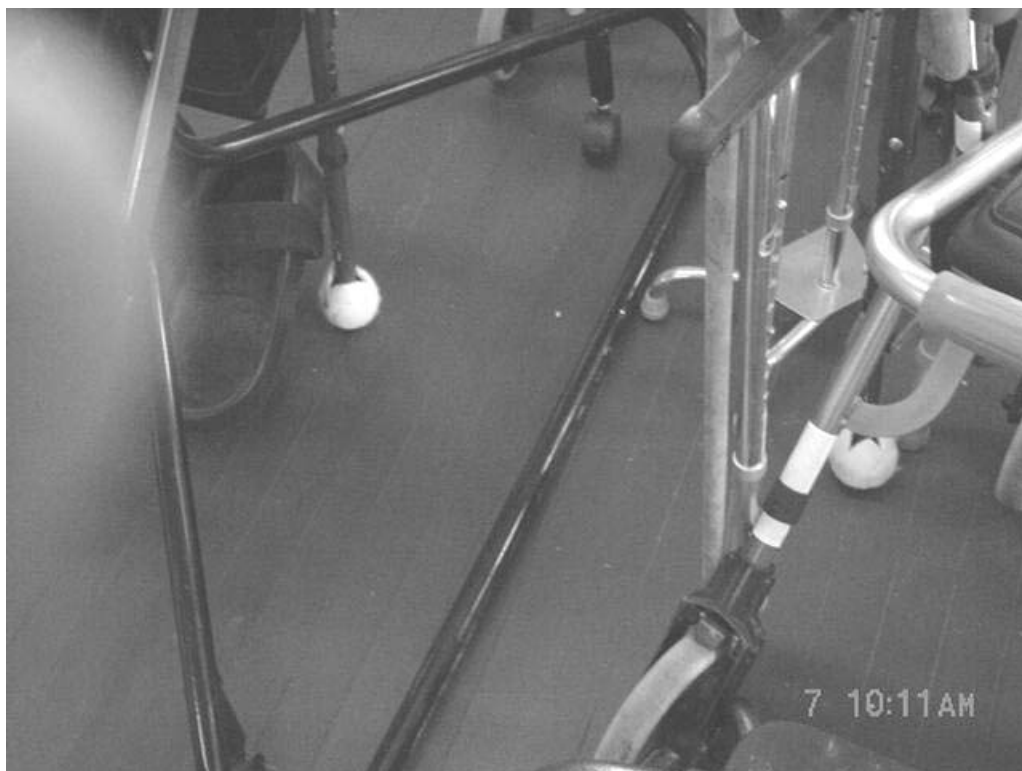
**Picture 10**

In an effort to reduce noise, tennis balls had been sliced open and placed on walker legs (Picture 10). Tennis balls are made of a number of materials that are a source of respiratory irritation. Constant wearing of tennis balls can produce fibers and cause TVOCs to off-gas. Tennis balls are made with a natural rubber latex bladder, which becomes abraded when used as a leg pad. Use of tennis balls in this manner may introduce latex dust into the environment. Some individuals are highly allergic to latex (e.g., spina bifida patients) (SBAA, 2001). It is recommended that the use of materials containing latex be limited in buildings to reduce the likelihood of symptoms in sensitive individuals (NIOSH, 1997). A question and answer sheet concerning latex allergy is attached as [Appendix C](#) (NIOSH, 1998).

**Tennis Balls on Walker Legs**

11. Change/clean filters for univents and air conditioning units as per the manufacturer's instructions or more frequently if needed.
12. Consider discontinuing the use of tennis balls on walker legs to prevent latex dust generation. Alternative "glides" can commonly be purchased from office supply stores, see Picture 12 for an example.

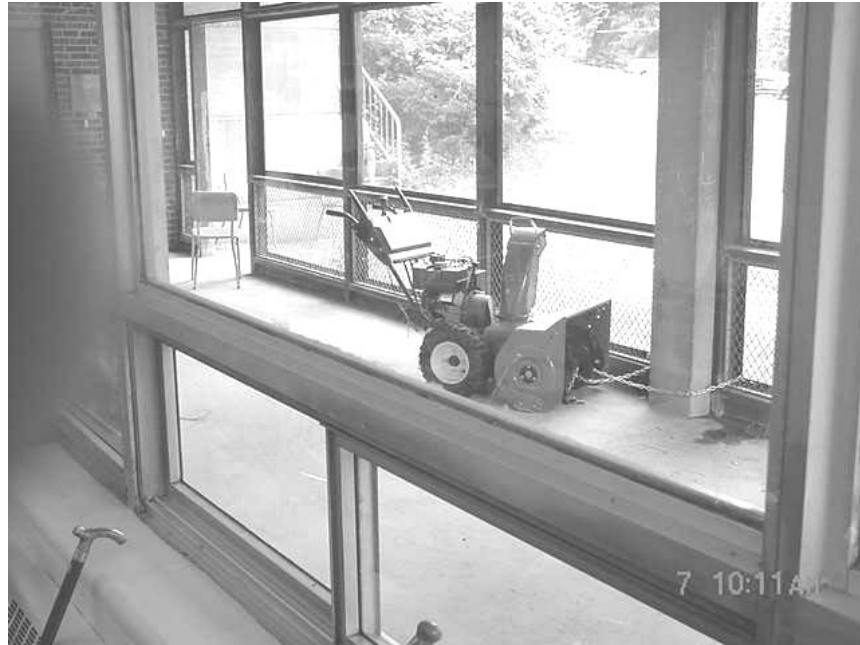
**Picture 11**

Finally, a snow blower was stored near the univent air intake for the clinical office (Picture 11). The close proximity of the snow blower to the air intake can result in fuel odors being entrained (drawn in) by the ventilation system and distributed to occupied areas.

**Snow Blower near Clinical Office Air Intake**

13. Relocate snow blower from vicinity of fresh air intakes.
14. Consult "Mold Remediation in Schools and Commercial Buildings" published by the US EPA (2001) for further information on mold. Copies of this document can be downloaded from the US EPA website at: [http://www.epa.gov/iaq/molds/mold\\_remediation.html](http://www.epa.gov/iaq/molds/mold_remediation.html).

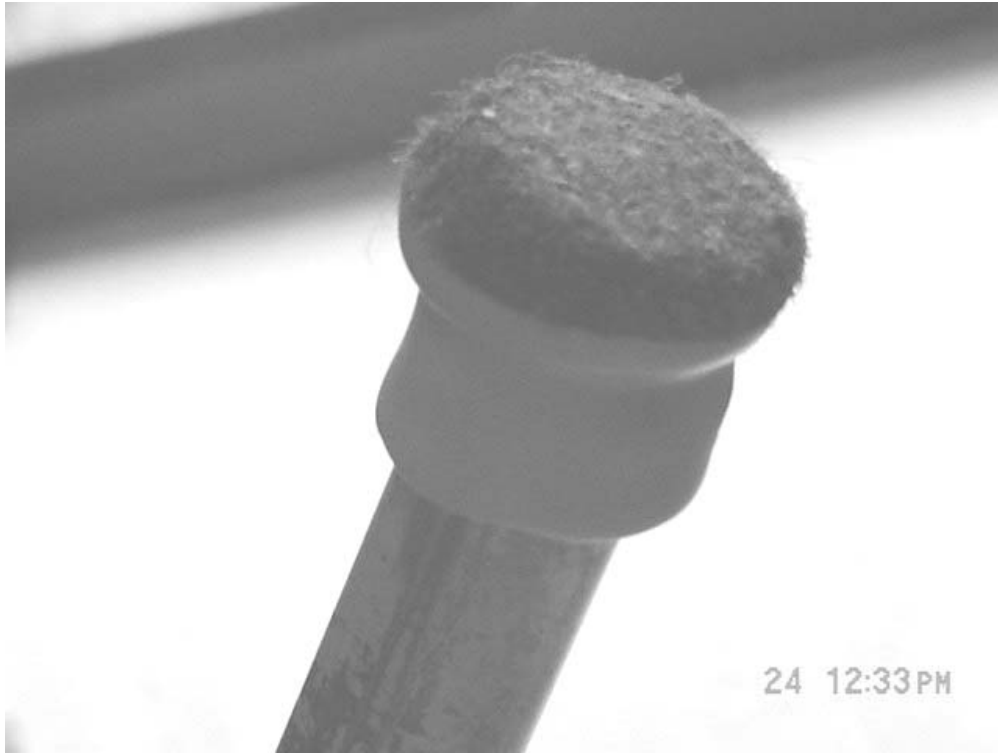
**Picture 12**

**“Glides” for Chair Legs that can be used as an Alternative to Tennis Balls**

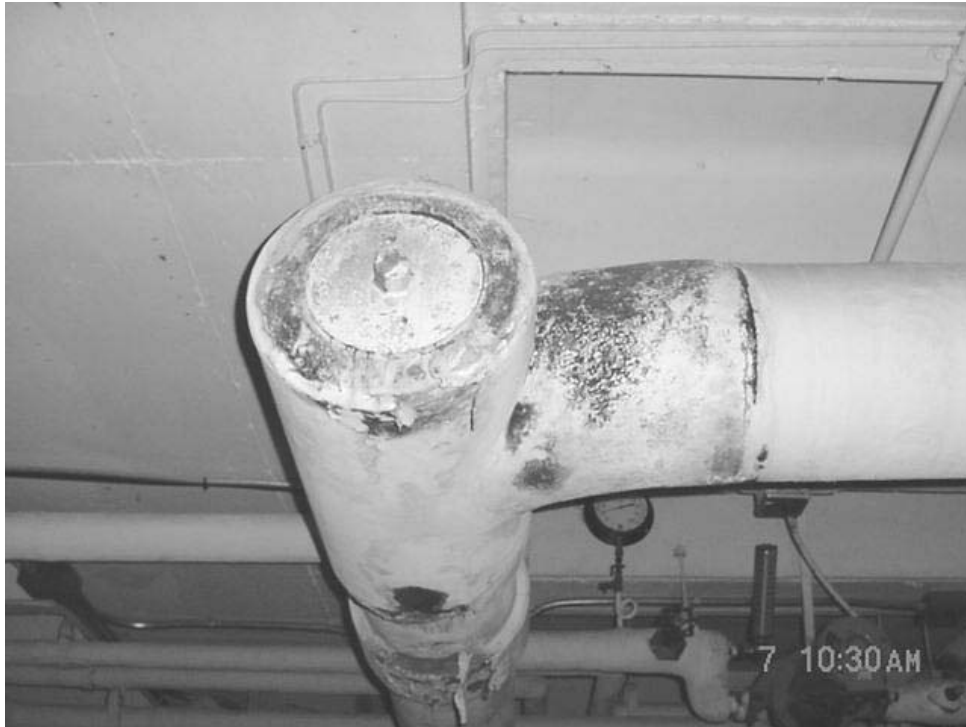
Picture 1

Throughout the storeroom, large portions of pipe insulation, as well as concrete ceilings and walls were observed colonized with mold (Pictures 1 to 3). In order for building materials to support mold growth, a source of water exposure is necessary. Identification and elimination of the source of water moistening building materials is necessary to control mold growth. In this case it appears that the source of moisture damaging pipe insulation is likely to be the chronic dampness and humidity that preceded the installation of mechanical ventilation. Ventilation in the basement storeroom is provided by a local exhaust fan mounted in the exterior wall and a passive supply vent on the opposite

**Mold-Colonized Pipe Insulation in Basement Storeroom**

Due to the extent of mold contamination, a professional mold remediation firm should be contacted to conduct remediation. In order to prevent potential mold and related spore movement and to reduce contaminant migration to adjacent areas during remediation, the following recommendations should be implemented.

2. Remove all mold-contaminated materials in accordance with *Mold Remediation in Schools and Commercial Buildings*, published by the US EPA (2001). The document is available at the US EPA website:  
[http://www.epa.gov/iaq/molds/mold\\_remediation.html](http://www.epa.gov/iaq/molds/mold_remediation.html).

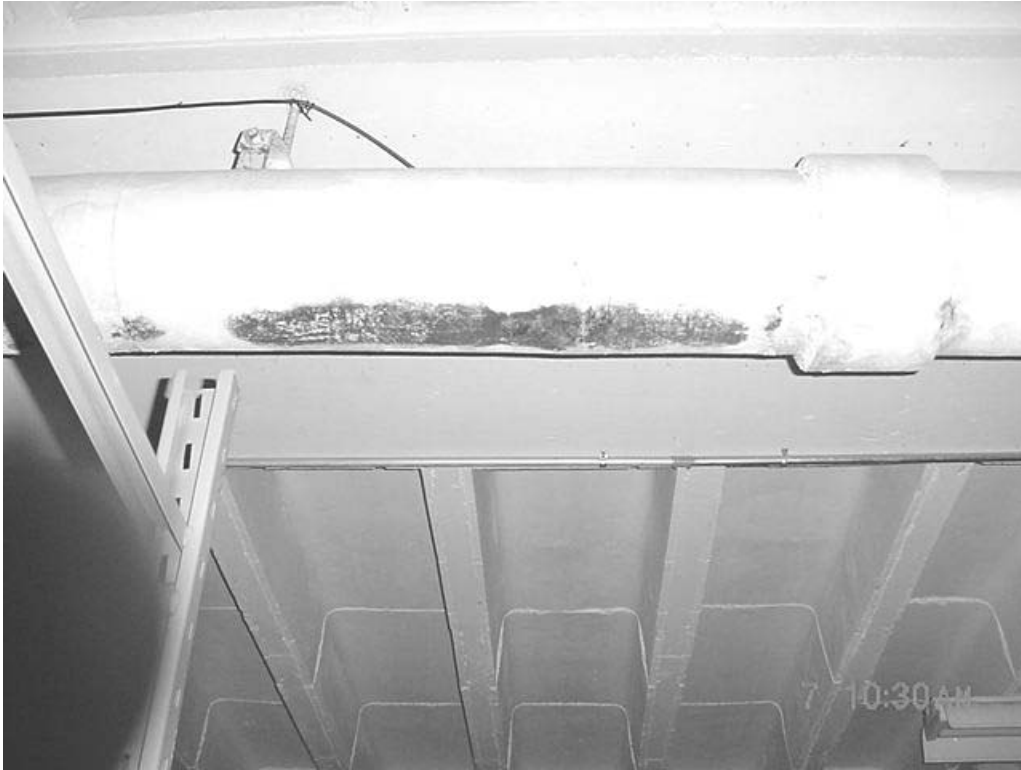
Picture 2

**Mold-Colonized Pipe Insulation in Basement Storeroom**

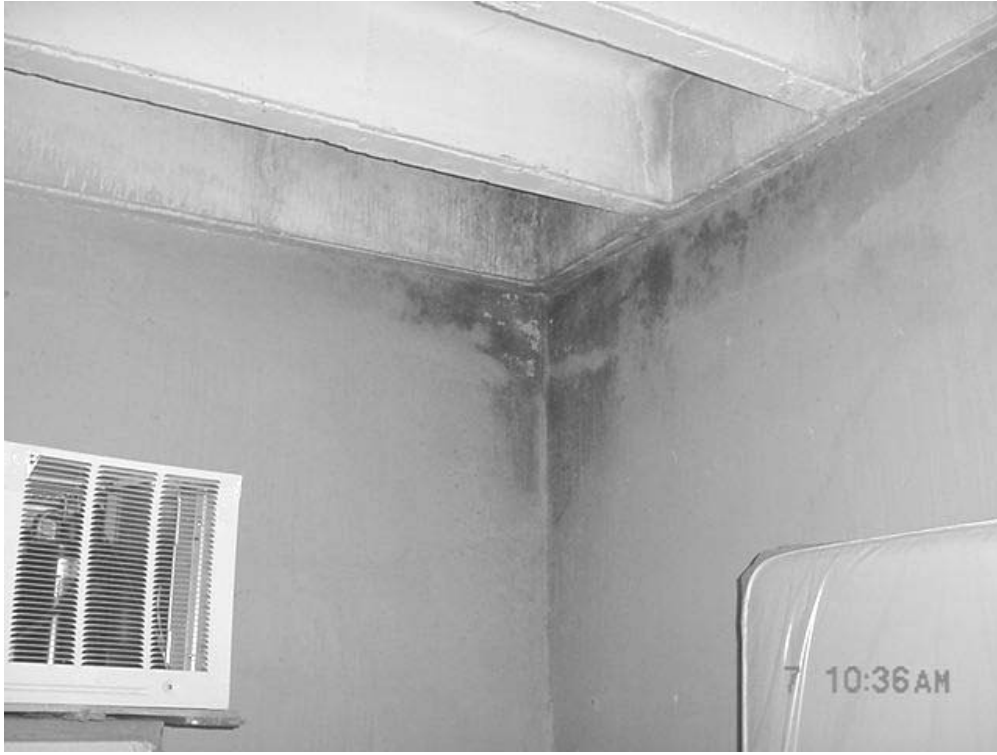
Picture 3

**Mold-Colonized Concrete Walls and Ceiling in Basement**

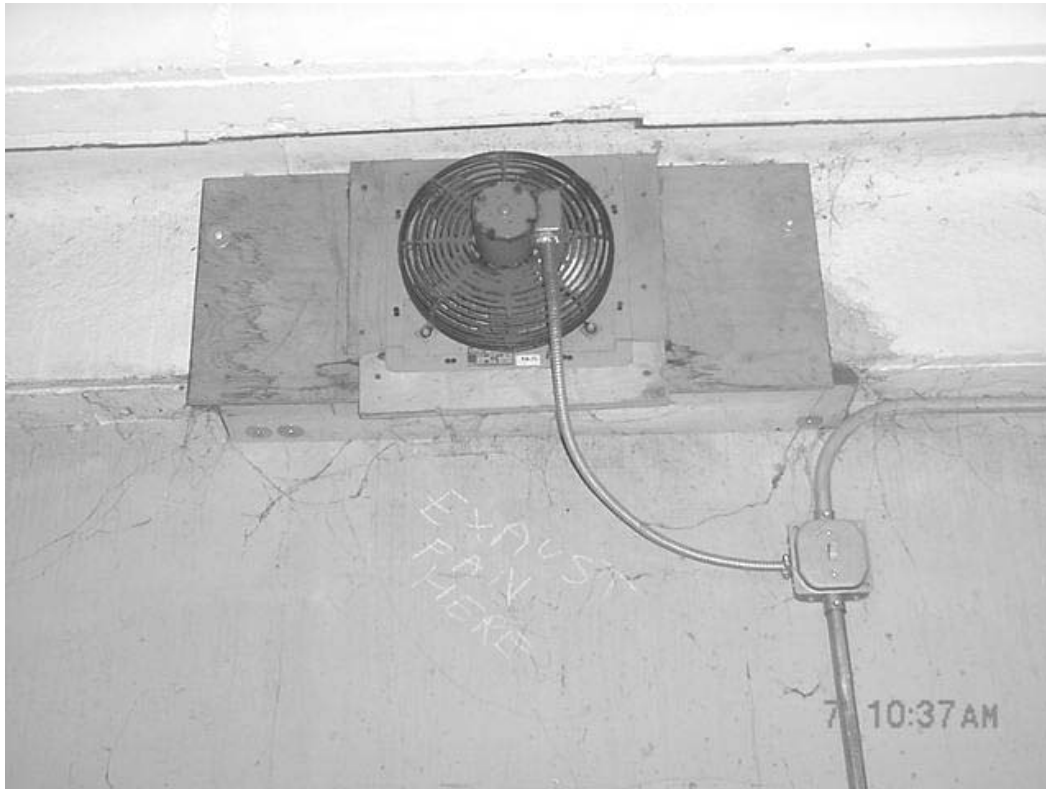
Picture 4

wall, for make up air (Pictures 4 and 5). Mr. Hyde reported that these vents were installed approximately twelve years ago.

**Local Exhaust Fan in Basement Storeroom**

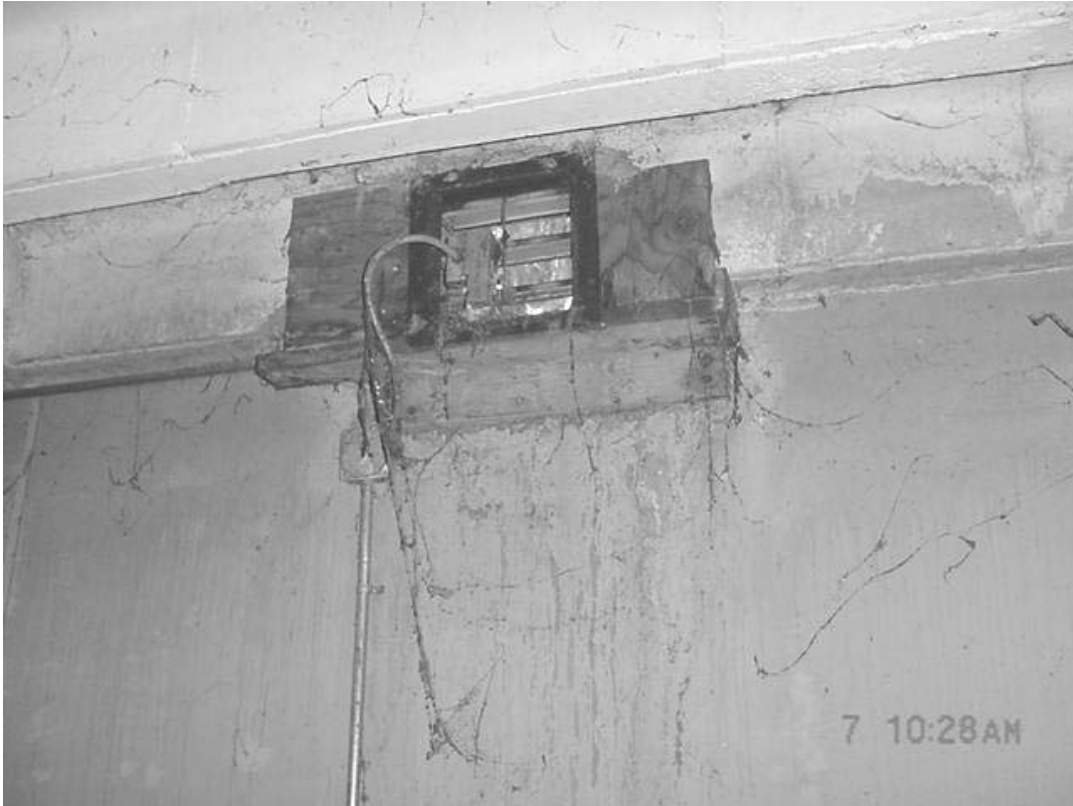
**Picture 5**

**Supply Vent for Make-Up Air in Basement Storeroom**

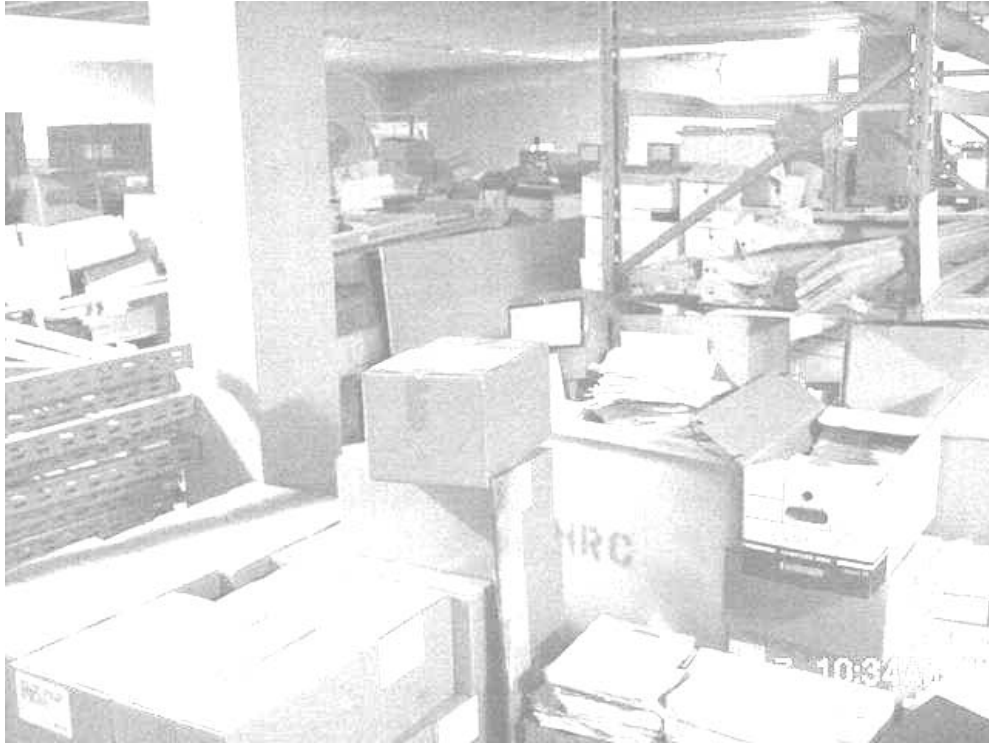
**Picture 6**

**Materials in Basement Storeroom**

1. Temporarily relocate materials stored in the basement during remediation activities (Picture 6). Discard porous materials (e.g., boxes, papers, files) that are deemed unworthy of preservation, restoration or transfer to another media (e.g., microfiche or computer scanning). Where stored materials, such as medical records, are to be preserved, restored or otherwise handled, an evaluation should be conducted by a professional book/records conservator. The preservation/restoration process can be rather expensive and may be considered for conservation of irreplaceable documents that are colonized with mold. Due to cost of conservation, disposal or replacement of moldy materials may be the most economically feasible option.
